# CORROSION OF WELD AREA AT INTERNAL SURFACE OF PIPELINE USED IN OIL AND GAS INDUSTRY

M.A. Azam<sup>1</sup>, M.F. Abdullah<sup>1</sup> and T. Shimoda<sup>2</sup>

**ABSTRACT:** The objective of this work was to investigate the cause of failed pipeline steel, in particular at its weld area which may due to the preferential corrosion. The pipeline sample was supplied by an industry based in Miri, Sarawak. The serious circumstances in the piping scheme led to high-level corrosion of the inner surface, particularly in the weld region. Inside the pipe system, natural gas flowed into the processing operation within the platform. Several tests and experiments were elucidated to comprehend the metallographic of the failure portion in order to explore the failure. Pipe sample testing techniques such as visual inspection, optical microscope, scanning electron microscope, and Vickers hardness testing were carried out effectively. The characterization of the microstructure was carried out on the sample taken from three main regions of the sample, which are the base metal, the heat affected area and also the weld joint, in order to elaborate the difference of the properties. The test outcome h

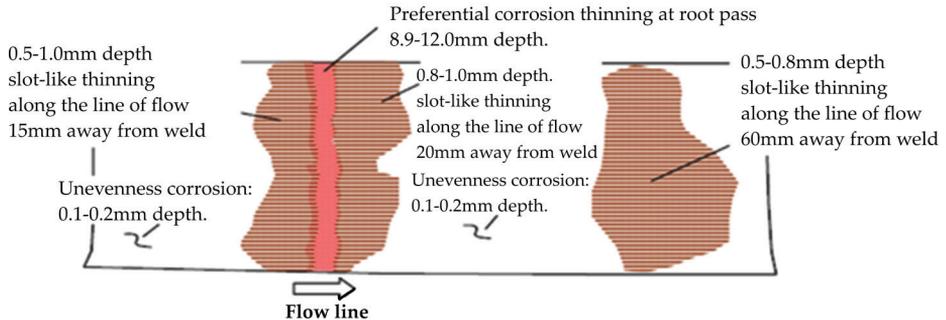
For inner surface, thin preferential severe corrosion was observed at all length of weld with 8.9 to 12.0 mm depth. Thin preferential corrosion was observed at both HAZ area, with the 0.8 to 0.9 mm depth, along

the line of flow. It is located at 15 mm to 20 mm width, at both upper stream side and downstream side. At downstream side, thin layer corrosion is scattered was observed, which is 75 mm from the weld, with the depth of 0.3 to 0.8 mm, along the line of flow. Schematic illustration in Figure 1 shows the inner side of the pipe.

Figure 1: The internal surface condition of the pipeline

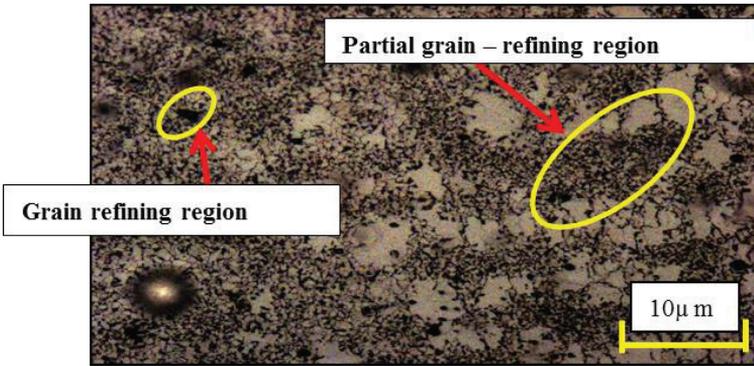
Grain-refining region is produced when austenite grains decomposed into the ferrite and pearlite grain distribution during cooling owing to restricted diffusion moment [14]. Pearlite is an eutectoid mixture containing 0.80% carbon and is formed at 727 ° C when cooled very slowly [15]. It is a very fine plate like or lamellar mixture of ferrite and cementite. Partial grain-refining region prior pearlite colonies turn into austenite and expand upon heating moderately to previous ferrite, then decompose into highly fine pearlite and ferrite grains during cooling. Pearlite is a mixture of alternate strips of ferrite and cementite in a single grain as in Figure 2.

Figure 2: Microstructure of HAZ parent at upstream (right side)

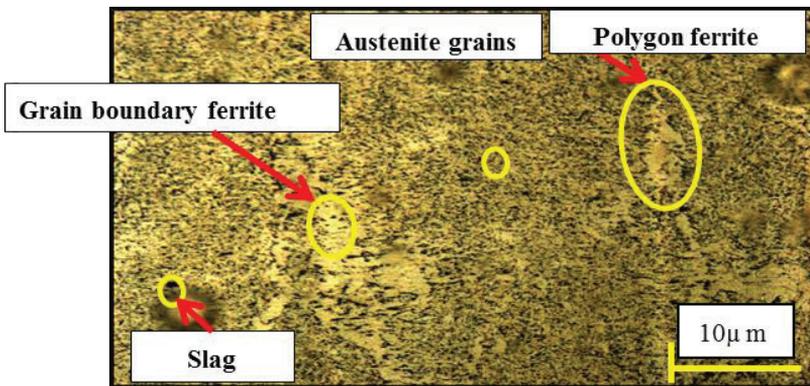
For microstructure of weld metal at upstream right side, pro-eutectoid ferrite forms along the austenite grain ferrite border when the weld metal is cooled in the austenite phase – ferrite transformation. In addition, polygon ferrite was also observed in the austenite grains in the form of coarse ferrite islands. Its presence reduces weld metal's toughness. With the increase in weld metal's carbon and chromium content, its amount decreases. Its quantity rises as heat input rises during welding and reduces as the weld metal's carbon and chromium content rises (Figure 3).

Figure 3: Microstructure of weld upstream (right side)

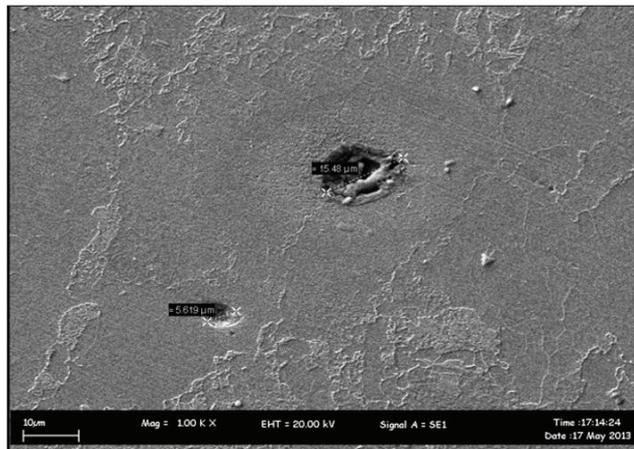
The examination was conducted on scale of 10- $\mu$ m with magnification of 1000 X, pitting have been observed at 2 points at HAZ area (Figure 4 (a)). The diameter of pitting A is 5.62  $\mu$ m and porosity B is 15.48  $\mu$ m, respectively. Pitting was confirmed by EDX result where only Fe element exists at the peak of the graph as shown in Figure 4 (b).

Figure 4: (a) SEM image and (b) EDX result of pipeline sample at HAZ upstream

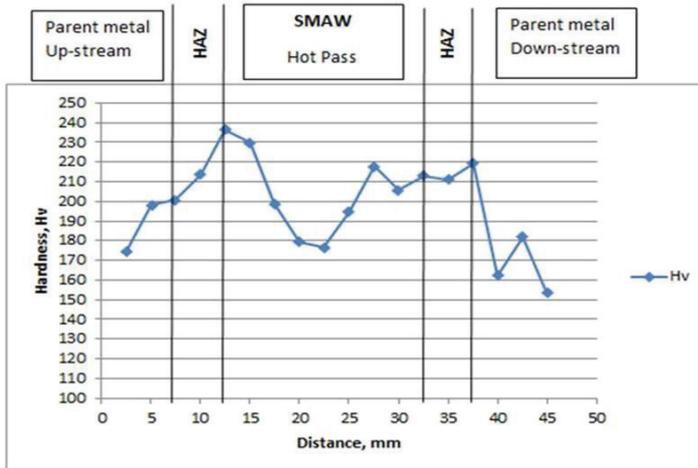
Figure 5 shows the hardness distribution of Vickers hardness testing. This pipe has served in severe condition where natural gas consist the most corrosive elements like carbon dioxide ( $\text{CO}_2$ ) and hydrogen sulfide ( $\text{H}_2\text{S}$ ), flowing inside the pipe system [16]. Additionally, the parent metal sustained the localized corrosion which related to the service temperature, conductivity of the corrosive element as well as thickness of the corrosive film in contact with metal has influence the parent metal properties to become erratic manner. Other factors that influence the changing of hardness distribution at parent metal is temperature ranging from ambient from welding to melting point.

Figure 5: Hardness distribution of samples at different areas

At HAZ, ferrite supplied the welds with excellent mechanical characteristics such as tensile strength due to the greater resistance to crack propagation of its microstructure with fine size. A microstructure of acicular ferrite that was growing at inclusion was also observed. This has given the hardness of HAZ is very high compared with base and weld metal. But there was a decreasing value at HAZ (left side). This is due to the existence of polygonal ferrite which its presence reduces the strength of the weld metal. Factor that contribute to the amount of this microstructure increase, when increasing the heat input during welding, and due to high carbon and chromium content supply by welding electrode in manufacturing.

Based on the metallography examination by using OM, the microstructure in the weld area was polygon ferrite. The presence of this microstructure reduces the toughness, same as in HAZ microstructure at location downstream (left side). The amount of microstructure increases due to the increase in heat input during welding. It also reduces with the rise in weld metal's carbon and chromium content, which is usually added by welding electrode. The microstructures in this weld metal are grain boundary ferrite and coarse grain structure or grain coarsening region. High heat input and low cooling rate lead in a region of grain coarsening, resulting in low

hardness, lower tensile strength, yield strength and ductile welding [17]. This has proved that the existence of polygon ferrite and grain coarsening region microstructure in this shielded metal arc welding (SMAW), result to low hardness value during this Vickers hardness testing [18]. And this is suggested to be caused by high heat input and low cooling rate.
