FRACTOGRAPHY OF WASPALOY WIRE DEPOSITED WITH LASER AND ARC ADDITIVE MANUFACTURING PROCESSES

ABSTRACT: Welding with filler material can be considered as an additive manufacturing process whereby it involves the deposition of molten metal in a form of droplets onto a substrate. Wire and Arc Additive Manufacturing (WAAM) and laser direct metal deposition (DMD) are applied for repair purposes, hard facing, and building structures in various industries such as the aerospace industry. In this research, High-Powered Diode Laser (HPDL) and Gas Tungsten Arc Welding (GTAW) were used as the heat sources to deposit Waspaloy wire layer-by-layer to form a thin wall. The heat flow during the deposition process causes a change in the microstructural and mechanical properties of the subsequent layers. Following the deposition process, solution treatment and aging heat treatment were performed on the Waspaloy thin wall. Understanding the process/property relationship is crucial to ensure the reliability of the built structure. Tensile testing was performed prior to fractography. Fractography is critical to the failure analysis of metals. The objective of this research is to study the microstructure

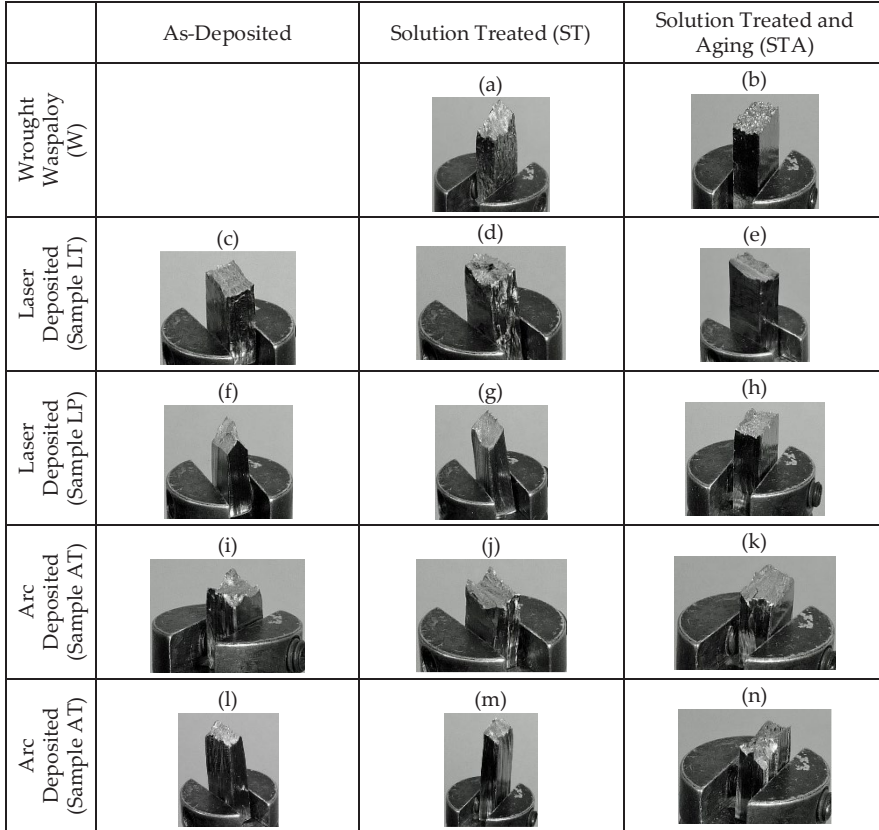
Figure 2: Macrograph of a cross-section through tensile fracture of (a) ST, (b) STA wrought Waspaloy, (c-h) laser, and (i-n) arc deposited Waspaloy.

Tensile testing was performed on the wrought, as-deposited, and heat-treated Waspaloy. The fracture occurred within the gauge length. The width and thickness of the samples were 6 mm and 3 mm, respectively. Figure 2 shows the macrograph of a cross-section through tensile fracture of (a) ST, (b) STA wrought Waspaloy, (c-h) laser, and (i-n) arc deposited Waspaloy. The macrographs for laser and arc deposited Waspaloy were taken for the middle sections of the thin wall.

In the case of wrought Waspaloy, macroscopic fracture surface for the ST material sheared with the fracture inclined at $\sim 45^\circ$ and for STA material fracture was perpendicular to the tensile axis as shown in Figure 2 (a) and (b), respectively. The overall morphology of the fracture surfaces for W(ST) and W(STA) samples is shown in the SEM fractography, Figure 3, at low and high magnifications. For the W(ST) material fracture occurred along the grain boundaries. Examination of the tensile fractures at the higher magnification indicates that grain boundary cracking and shallow dimpling can be seen. There are dimples of varying sizes with shallow and fine microscopic voids. In the W(STA) sample, similar features are seen but with uniformly distributed and deeper microscopic voids. Grain boundary cracking is also visible. The intergranular dimple rupture in the W(STA) sample is

On the macroscopic scale, the tensile fracture of the LT material was by shear with the fracture inclined at $\sim 30^\circ$ to the tensile axis as shown in Figure 2 (c). The overall morphology of the fracture surfaces for LT samples is shown in Figure 4 (a) and exhibits a clear dendritic pattern with interdendritic cracking. This suggests that the fracture took preferentially along the interdendritic region. The interdendritic cracking probably occurred at the dendrite boundaries and initiated around the interdendritic carbides. There are dimples with fine

Tensile fracture of the LP material was by a combination of shear with the fracture surface inclined at $\sim 30^\circ$ and perpendicular to the tensile stress as displayed in Figure 2 (f). The fracture surfaces of the LP samples as shown in Figure 4 (c) reveal a dendritic pattern with a cruciform shape. Interdendritic cracking was noted. Dimples and microscopic voids observed at higher magnification indicate the sample has experienced ductile fracture by microvoid coalescence. MC type of carbides was found in the dimples suggesting the potential location of fracture initiation. The cruciform pattern is prominent due to the ductile shear of the dendrites, which probably the last feature to have failed during the test.

Tensile fracture of the AT material, which is represented by Figure 2 (i) was almost perpendicular to the tensile axis at the width of the test bar but shear approximately 45° at the thickness of the test bar. The overall morphology of the fracture surfaces for AT samples, as shown in Figure 5, exhibits a clear dendritic pattern similar to the LT materials. However, the dendritic pattern for the AT material appears to be smaller. The fracture surface features of the AT are similar to the LT in regard to the dendritic pattern, interdendritic cracking that might be initiated by the by grain boundary MC type of carbides, and dimples with microscopic voids which indicate a ductile fracture.

On the macroscopic scale, the tensile fracture of the AP material was perpendicular to the tensile stress as in Figure 2 (l). The overall morphology of the fracture surfaces for AP samples as shown in Figure 5 exhibit similar to the LP in regard to the dendritic pattern, interdendritic cracking, and dimples with microscopic voids which indicate a ductile fracture. However, the interdendritic cracking is more apparent in AP than LP materials.

The tensile fractures of the LT(ST) were by shear with the fracture surface inclined at $\sim 45^\circ$ to the tensile stress at the thickness of the tensile test bar as shown in Figure 2 (d). Similarly, the fracture surface of AT(ST) samples was also sheared with an inclination of $\sim 45^\circ$ to the tensile stress (Figure 2 (j)). The overall morphology of the fracture surfaces for LT(ST) and AT(ST) samples exhibits a similar feature

In the case of LT(STA) and AT(STA), the macroscopic fracture surface was perpendicular to the tensile axis as shown in Figure 2 (e) and (k). The overall morphology of the fracture surfaces for LT(STA) and AT(STA) samples exhibits a similar feature which showing a dendritic 'ghost' pattern. The dendrites were significantly reduced after the solution treatment. The formation of the dendritic pattern in the fracture surface might be due to the carbide phase in the interdendritic region. Interdendritic cracking could be observed in both LT(STA) and AT(STA) materials. Interdendritic cracking by the grain boundary carbides was noted. The $M_{23}C_6$ type of carbides was detected at the fracture surface. Dimples with microscopic voids indicating ductile fracture and particles observed in the dimples are most likely to be the fine γ' precipitates.

On a macroscopic scale, the tensile fractures of the LP(ST) and AP(ST) samples were by shear with the fracture surface inclined at $\sim 45^\circ$ to the tensile axis as shown in Figure 2 (g) and (m), respectively. The overall morphology of the fracture surfaces for LP(ST) and AP(ST) samples exhibits similar features which showing a dendritic pattern with cruciform shape although dendrites were significantly reduced after the solution treatment. Interdendritic cracking by grain boundary MC type of carbides could be observed in both LP(ST) and AP(ST) materials. Dimples with microscopic voids which indicating ductile fracture was evidently similar.

In the case of LP(STA) and AP(STA), the macroscopic fracture surface was perpendicular to the tensile axis as shown in Figure 2 (h) and (n). The fracture surface feature of the LP(STA) was similar to the AP(STA) in regard to the dendritic 'ghost' pattern and grain boundary cracking. The $M_{23}C_6$ type of carbides was detected at the fracture surface. Dimples with microscopic voids indicating ductile fracture and particles observed in the dimples are most likely to be the fine γ' precipitates. Intergranular fracture in LP(STA) and AP(STA) material was more apparent as compared to those as-deposited and solution treated. This is might due to the formation of a film of $M_{23}C_6$ type of carbides [10].
